RFB-2021-15
Elston Hall Facade
ADDENDUM #3

REPORT OF LIMITED ASBESTOS AND LEAD PAINT INSPECTION

**Location of Inspection/
Building Owner:** Elston Hall
Schenectady County Community College
Washington Avenue
Schenectady, New York 12305

Alpine Project #: 20-26296-A

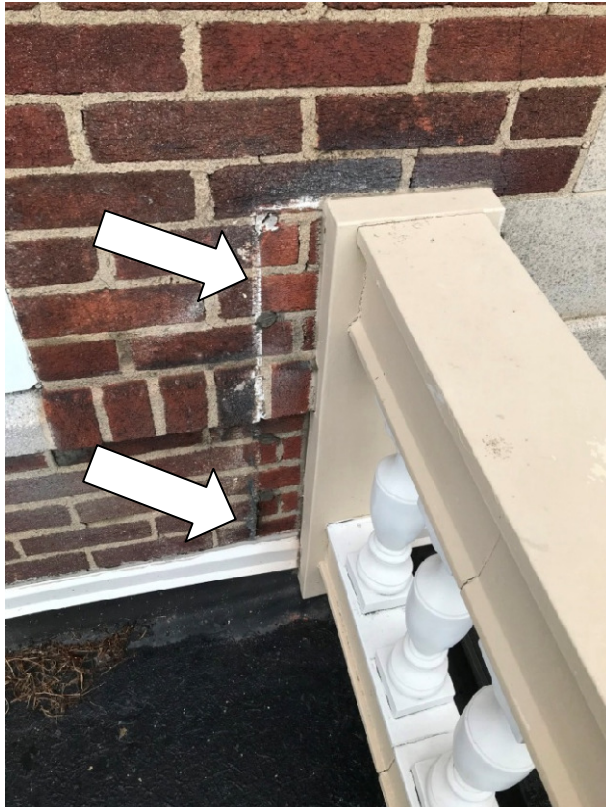
Asbestos Black and White Caulk – Center Core East Side at Old Railing Spot

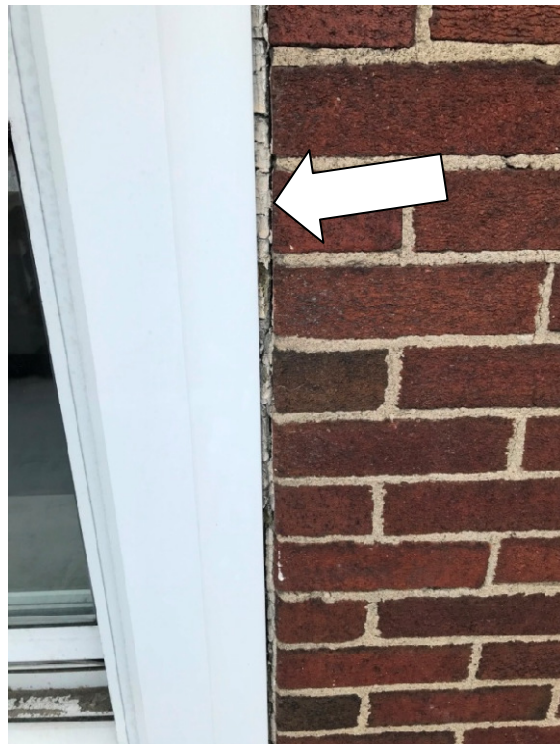
Asbestos Window Sealant

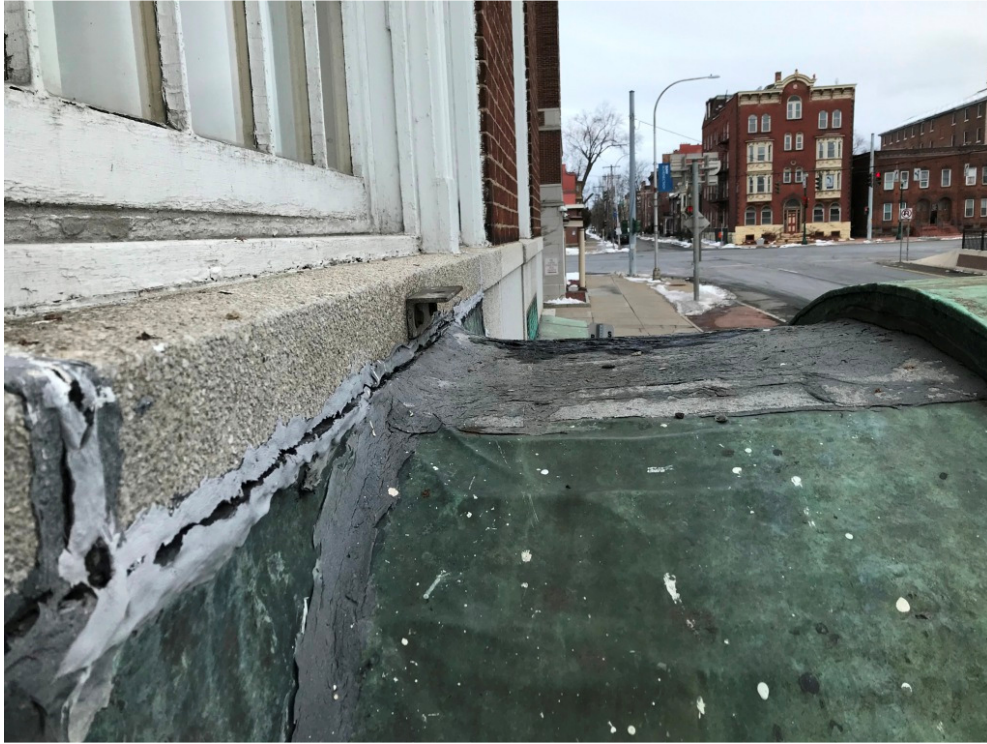
Asbestos Black & Gray Tar on Copper Roof – South Building East Side

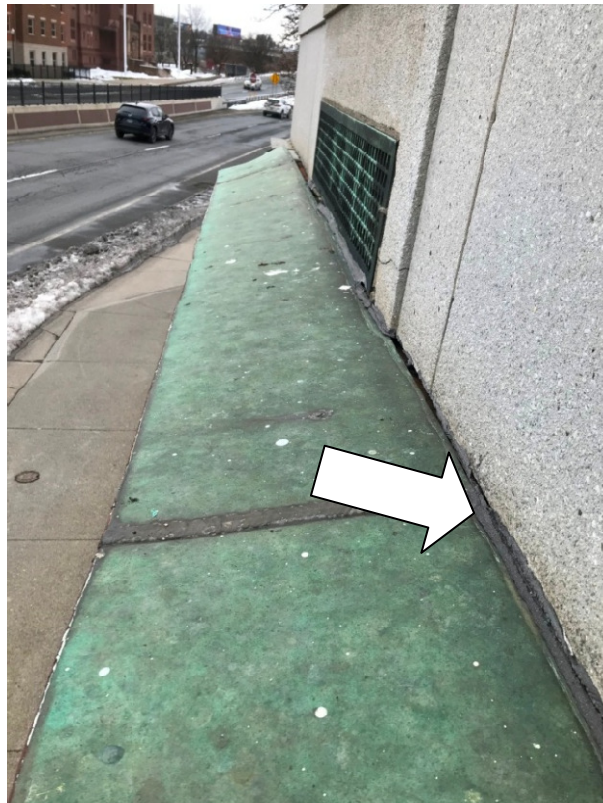
Asbestos Black Tar on Window "Eyebrows" – South Building East Side

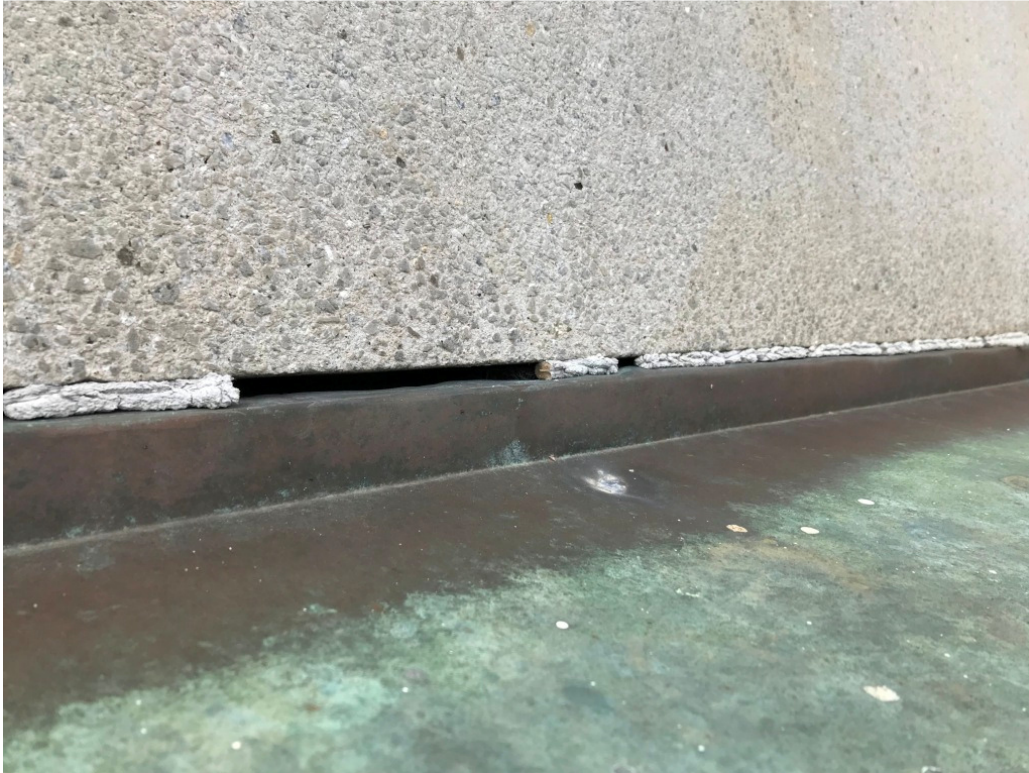
Asbestos White Caulk – North Building East Side Window “Eyebrows”

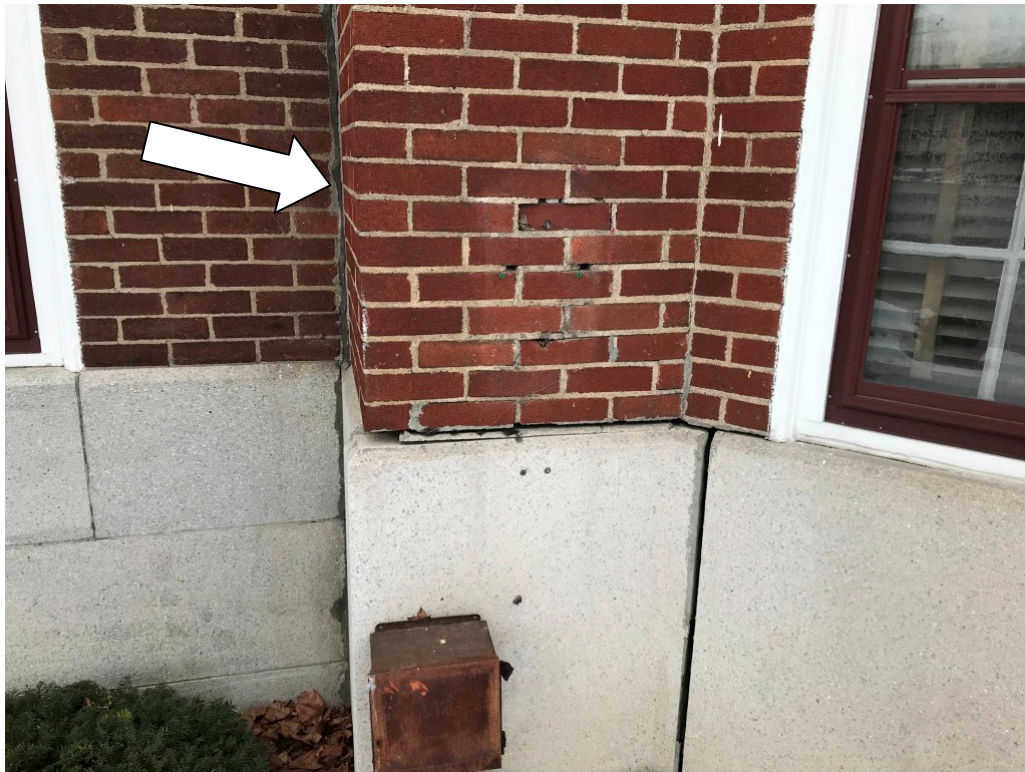
Asbestos Black Tar – North Building North Side Bump Out
